2020 - SIRM

Special COVID-19 Bulletin

October 2020

**SAFETY  
ISSUE  
REVIEW  
BULLETIN**

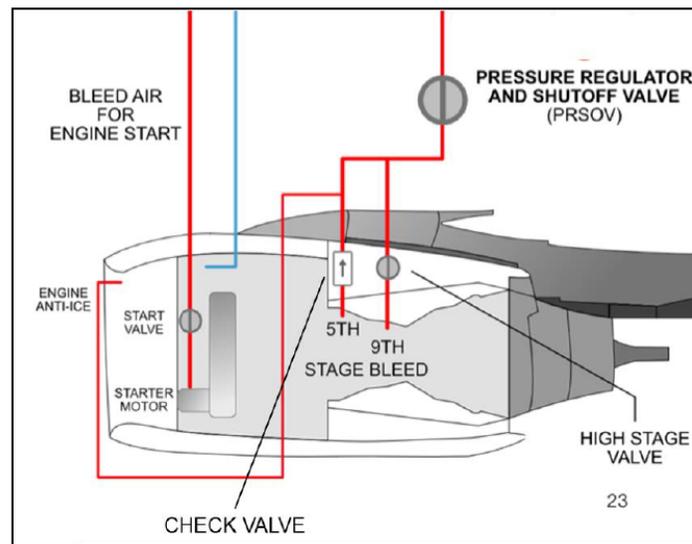
An engine restart was later attempted, with no success. The 737 landed with a single engine at its original destination, without further issues. During the post flight maintenance inspection in engine #1, it was found that the bleed air 5th stage check valve was seized in the open position.

In the incident flight, as the descent started and the 9th stage valve modulated open, the 5th stage check valve remained seized in the open position. That caused 9th stage compressor air to be re-ingested to the 5th stage of the compressor, resulting in engine stall.

Corrosion was later found on the seized valve. It is highly probable that the environmental and humidity conditions at the storage airport contributed to the development of corrosion on the component.

- As soon as the 5th stage check valve was found seized, the Engineering and Safety teams issued an order to inspect all engine check valves that had just returned to service after prolonged storage.
- A Safety Recommendation issued by the Investigation Committee determined the design of a new pilot's record database, to improve monitoring of flight crew performance during simulator training and check rides.

- Boeing updated the Aircraft Maintenance Manual (AMM) procedures for return to service from active storage and prolonged parking to include inspection of the 5th stage bleed air check valve.
- The Federal Aviation Administration (FAA) issued an Emergency Airworthiness Directive (EAD) for all stored Boeing 737 Classic and Next Generation. The EAD covers the engine bleed 5th stage check valve on aircraft that were stored for seven or more consecutive days. The FAA issued the EAD following four separate incidents caused by 5th stage check valve seizure.

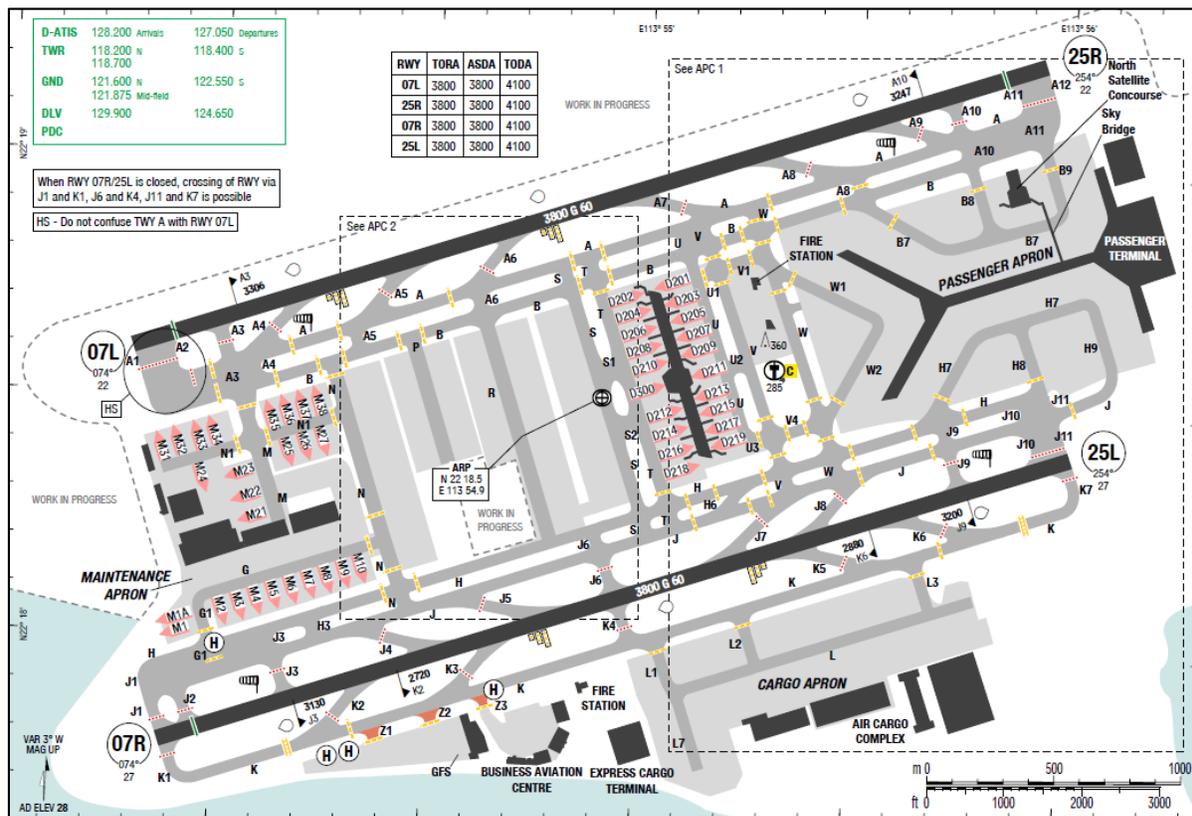
**Figure 1** above shows HKGLIDO Airport Ground Chart (AGC). ILS antennas are indicated by this symbol

In recent months, a series of incidents related to ILS signal interference have occurred in Hong Kong, leading to unstable approaches, go-arounds and loss of terrain separation, attracting public and media interest. The possibility of ILS signal interference when approaching to Hong Kong (HKG) airport, especially on runways 07R and 25L, is a known issue due to the location of the ILS antennas and terrain features.

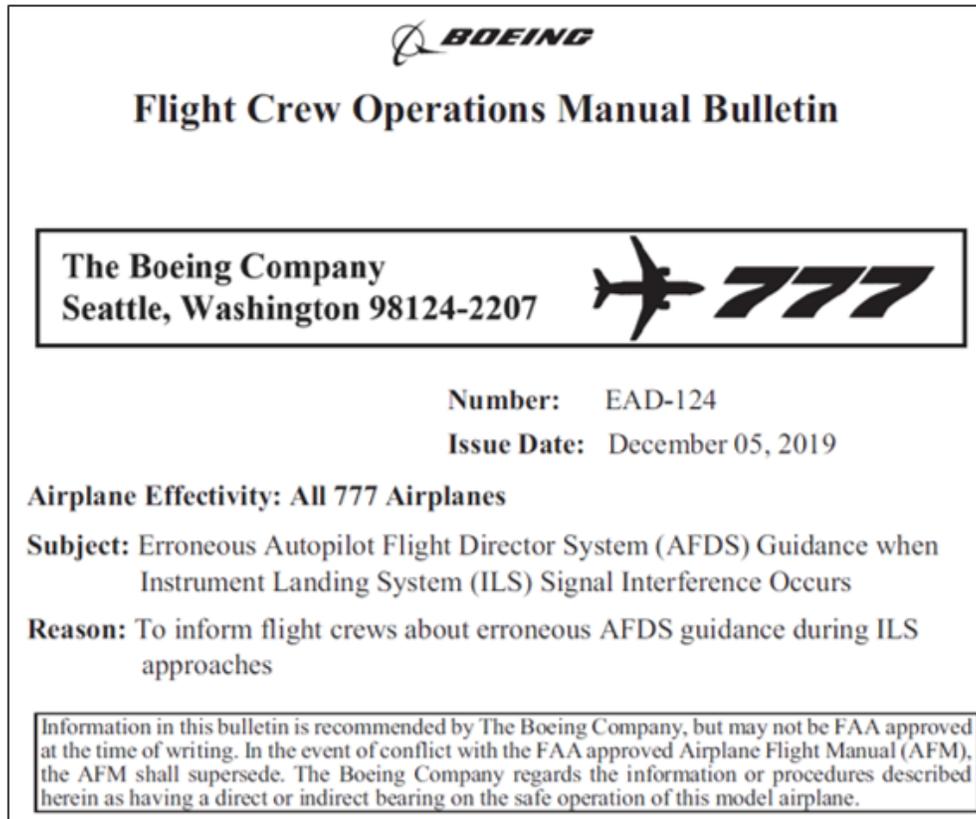
**Figure 2** above shows the Boeing Flight Crew Operations Manual (FCOM) Bulletin

The threats from an ILS signal interference are increased in certain Boeing models due to the possibility of an undesirable behavior of the AFDS system. In December 2019, Boeing issued a Flight Crew Operations Manual Bulletin (FCOM) highlighting the threats of erroneous Autopilot Flight Director System (AFDS) guidance when ILS signal interference occurs. The Boeing bulletin describes the AFDS operation during periods of localizer or glideslope signal degradation or signal instability, and the possible flight deck effects during such an event. The AFDS may initially attempt to track the degraded or unstable radio signal which may lead to large changes in pitch, high descent rates, or a pitch angle lower than required to normally track the glideslope.

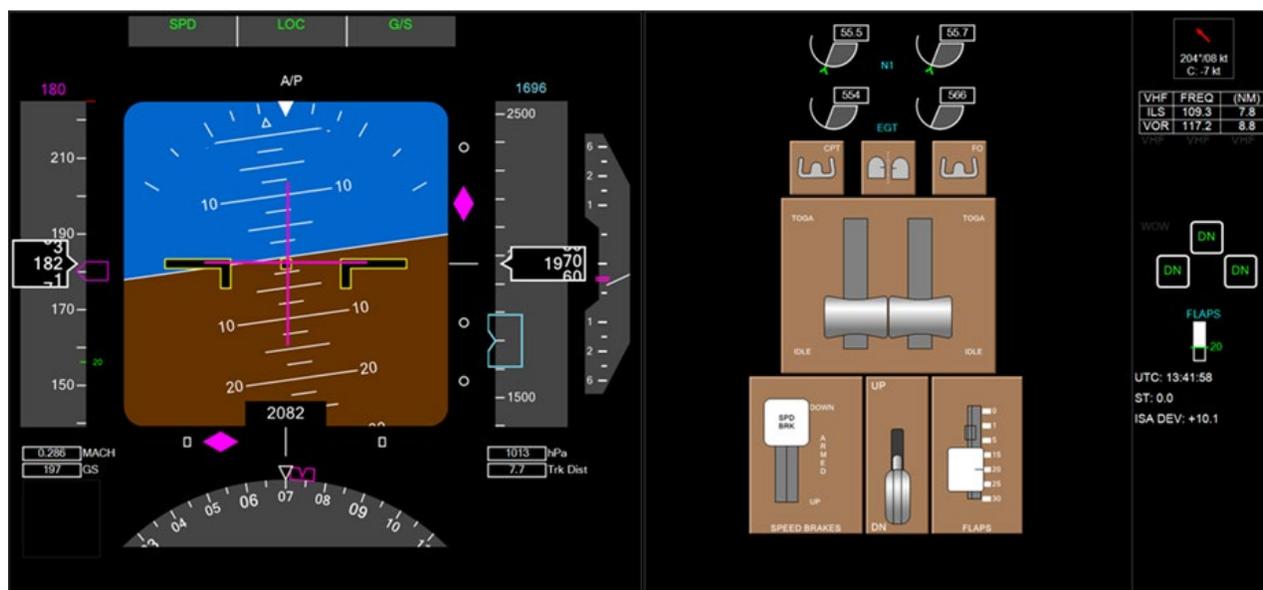
Figure 5 above shows the moment of the false glideslope capture

The flight crew did not initially recognize the false glideslope capture and allowed the aircraft to continue the descent below the ATC cleared altitude and minimum procedure altitude for the approach segment. After a short period of startle, the flight crew recognized the early descent and the aircraft was levelled off. Since the runway was in sight, terrain separation assured and the aircraft had not descended below the company stabilization altitude, the ILS was re-captured once the signal interference was resolved, and the approach continued.

The possible root cause for the ILS signal interference was a Boeing 757 that was holding at the runway 07R CAT I holding point at taxiway K1.

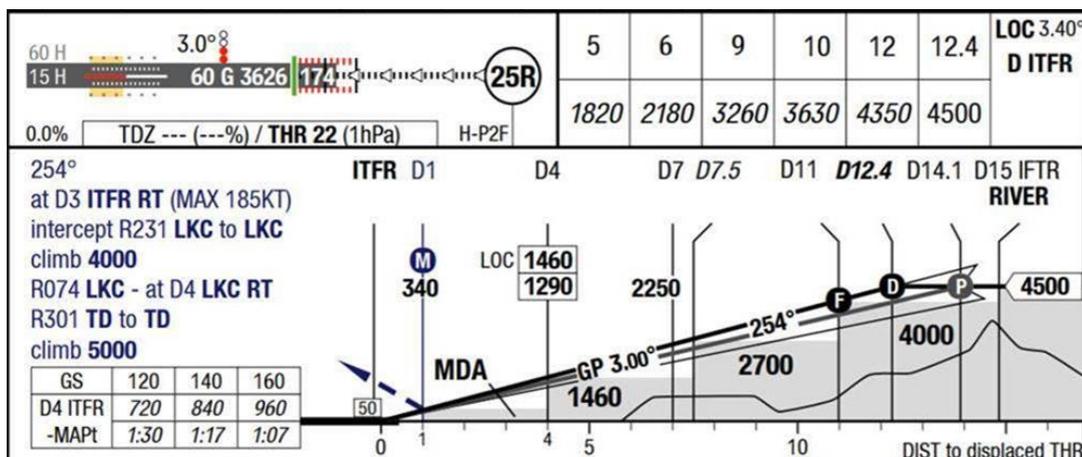
One of the mitigation strategies planned by the PF, was to closely monitor the altitude versus distance crosschecks using the approach chart table. However, the PF failed to notice that the distance versus altitude table refers to the non-precision LOC only approach with a 3.4° GP angle instead of the ILS approach 3.0° GP angle.

**Figure 6** above shows the ILS 25R LIDO IAC chart profile view and the distance versus altitude table for the non-precision LOC only approach.

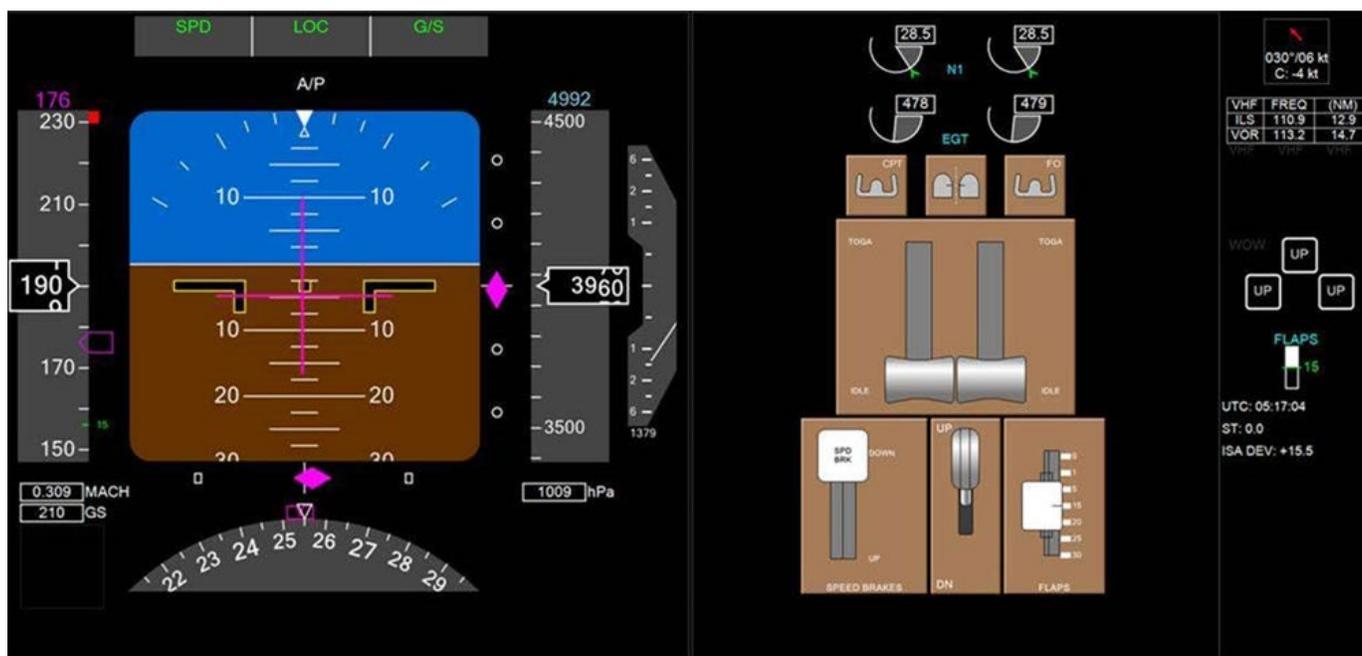
*Figure 7* above shows the moment prior to the autopilot disengagement by the PF and the momentary PFD pitch down indication when the altitude versus distance crosscheck was first performed by the flight crew

It is believed that the momentary pitch down attitude and rate of descent was the result of the AFDS correcting a small above glide path deviation caused by an increase in the aircraft indicated airspeed due to a wind shift, and not the AFDS behavior described in the Boeing Bulletin.

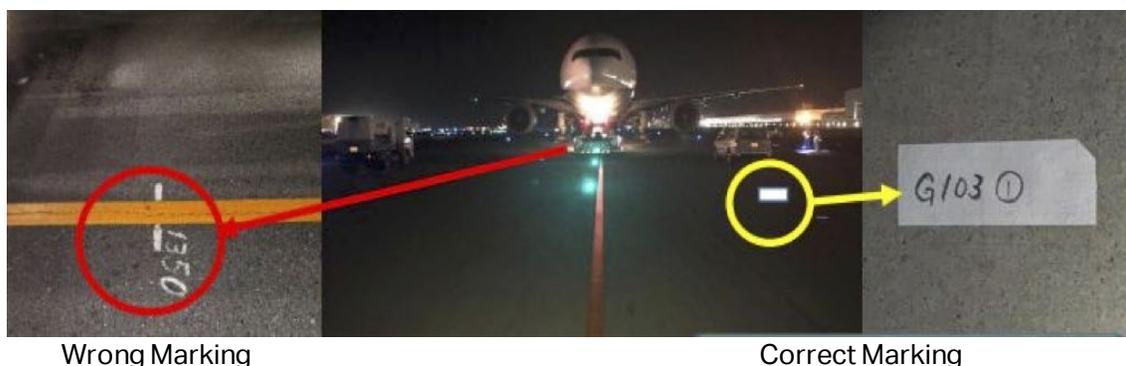
The investigation revealed that the position to identify the correct temporary spot marking was written on a duct tape-like material (because of it's temporary use) at 4.3m away from the TWY center line and not at the edge of the TWY. If it were written on the TWY centerline, the marking could not be seen by the towing operator.

- If the parking of an aircraft is different from the designated area, confirm the parking procedure between the towing operator and the assistant before starting the tow.
- If there is (are) any doubt(s) about the procedures or any concerns, it is strongly recommended to stop the work until the confusion is resolved.
