2020 - SIRM

Special COVID-19 Bulletin

October 2020

**SAFETY  
ISSUE  
REVIEW  
BULLETIN**

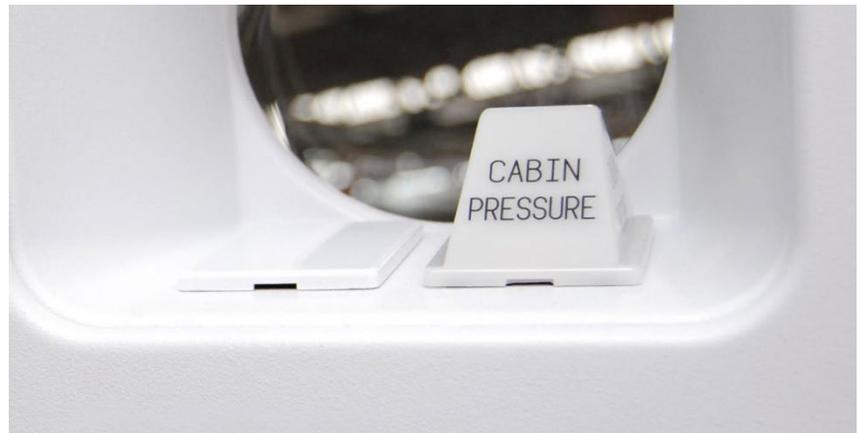
An operator reported to Airbus structural damage on an A320 family aircraft. The aircraft required the completion of periodic maintenance in the cabin, and to make a comfortable working environment the aircraft cabin was being conditioned. As part of the storage conditions the aircraft was also in ditching mode. This combination of factors led to an increase in cabin pressure. To continue the maintenance action the crew opened the forward passenger door - which opened explosively - causing minor damage to the aircraft structure. Fortunately, in this event, no injuries occurred.

Opening a cabin door when the aircraft is pressurised can cause serious injury (ref EASA SIB 2019-02 dated 12 February 2019). With more aircraft in parking/storage conditions, there is an increase in the risk of the scenario described above occurring. Indeed, due to the storage requirements - both the physical disconnection of batteries and design of the system - the existing residual pressure warning systems will not be operational.

It is therefore reminded that when accessing an aircraft to follow the manufacturer maintenance recommendations to ensure that the cabin is not pressurised - disconnecting any ground conditioning equipment and seeing if an internally opening access door (e.g. avionics access door) can be opened. Similarly, when working in an aircraft ensure that the aircraft is not being conditioned at the same time as all outlets are closed (e.g. in ditching mode).

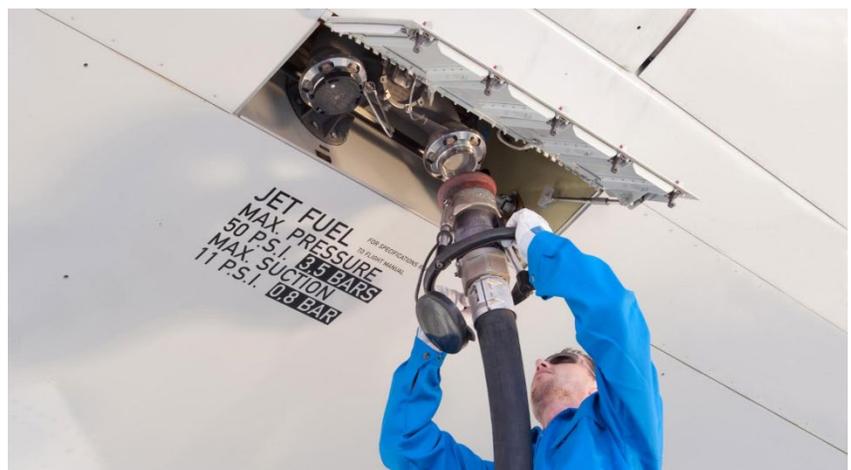
Treatment is timely and costly, but microbiological contamination can have numerous safety effects - from erroneous fuel gauging to the blocking of fuel filters to extreme cases where structural corrosion can occur.

Prevention is better than a cure, microbiological contamination requires a combination of three factors - microbes, fuel and water. Since the presence of the microbes cannot be eliminated, and fuel is required in the tanks when storing the aircraft, in order to prevent fuel contamination the action is to remove the water. This can be done by regular water drainage.

Whilst a scheduled water drainage task is likely to be included in the parking/storage procedures, operators should assess and adjust this accordingly. It may be that the drainage interval for normal operations may no longer be adequate, and as a consequence the interval should be reviewed and if necessary reduced. Regular water drainage and also fuel contamination checks can help avoid an expensive problem before it occurs.

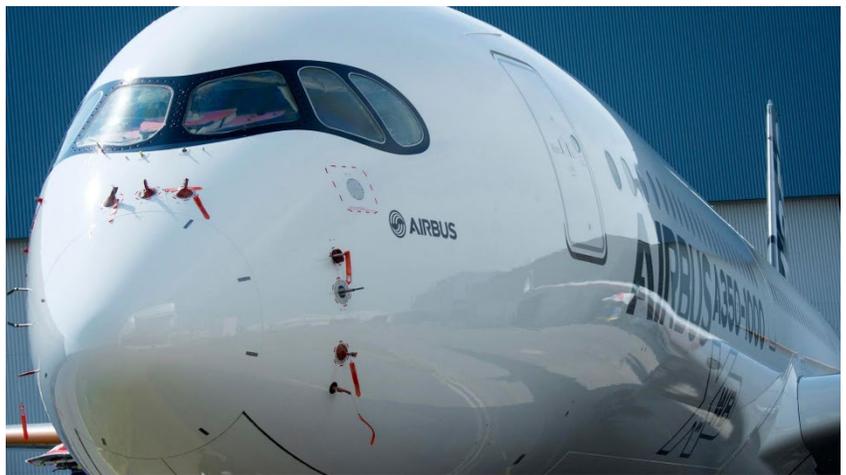
The most common cause of erroneous air data is due to contamination of the sensor - in the form of dirt or debris from insects, or due to water or moisture contamination if the probes are not correctly protected during washing or in high humidity conditions.

As well as Airbus communication, EASA has also issued a reminder to operators on the increase of Pitot Static issues after storage - Refer to SIB 2020-14 dated 05 August 2020. Airbus supports the recommendations issued and reiterates the importance of ensuring that the aircraft air data probes are correctly protected from the environment during parking or storage.

Even if covers are used, it is also recommended that before return to service particular attention is paid to the condition of the air data probes, and to flush the lines to ensure that there is no blockage.

It is reminded that to protect the air data probes, for storage and for cleaning purposes, only official equipment should be used. This has been designed and tested for the purpose. Use of "homemade" protections (plastic wrapping, bubble wrap, cellophane etc) is not approved, and could cause damage causing air data inaccuracy on return to service.
